# Manhole Inspection Summary

Manhole # S21CC1054MH

**Location** Address: **1700 CLIPPER PARK RD** Cross Street: **UNION AVE**

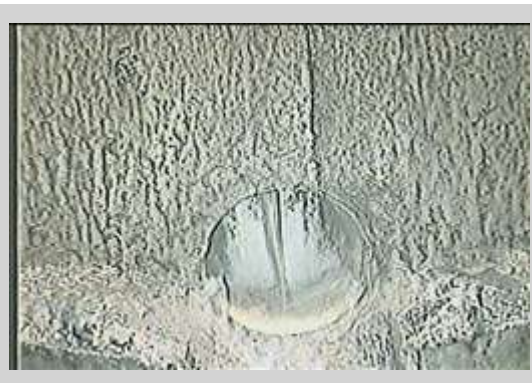
### Drop In @ 3 O'Clock

Drop: **Outside** Rod and Bar

Angled: **Yes** Reading: **10.20** (ft.)

Drop Condition: **Open**
